Pre-Purchase Inspection - Building Report

Complies with Australian Standard AS 4349.1 - 2007

Dwelling at:

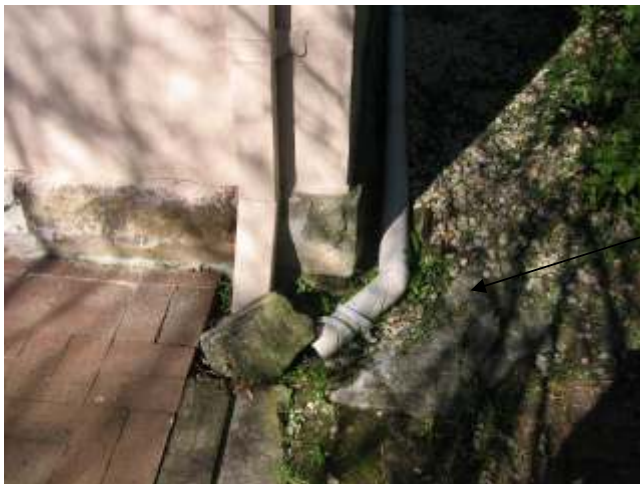
The right side stormwater drainage needs to be correctly connected into appropriate stormwater drainage.

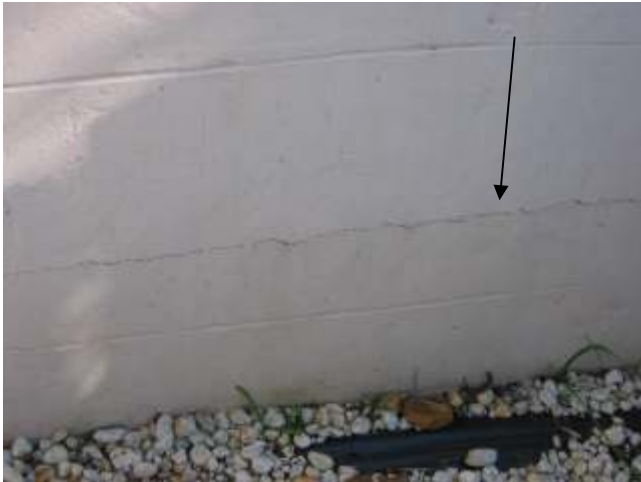
The left side of the garage wall is cracked, minor.

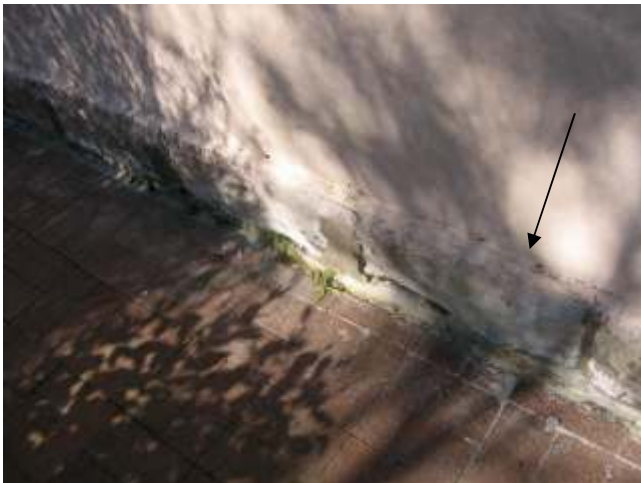
Some of the sandstone fender walls are damaged by rising damp in areas.

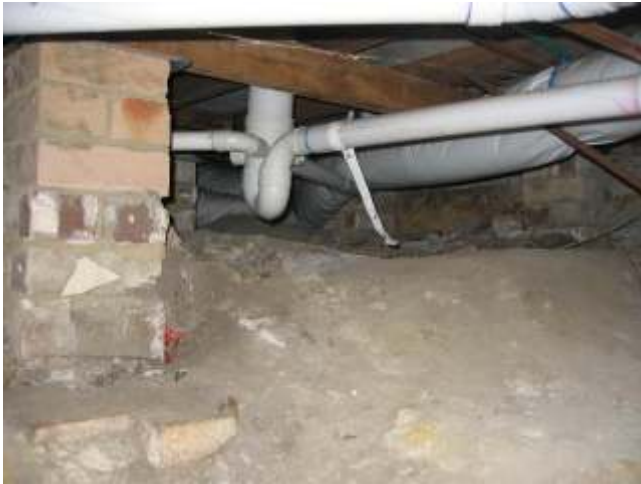
The rear left side sub floor access into an area that can not be accessed.

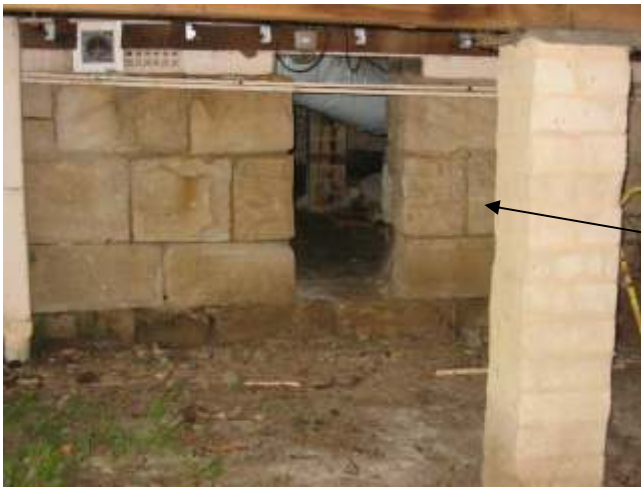
The other sub floor access area under the rear decking.

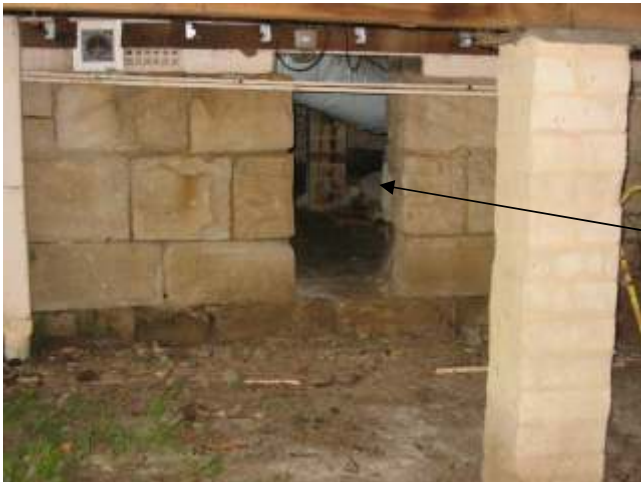
The other sub floor access area under the rear decking.

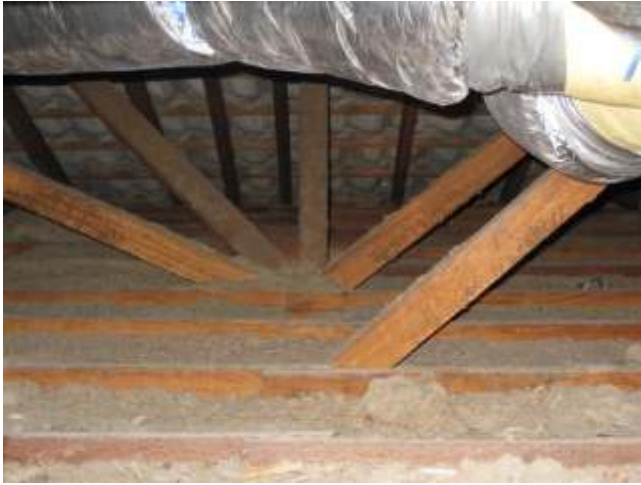
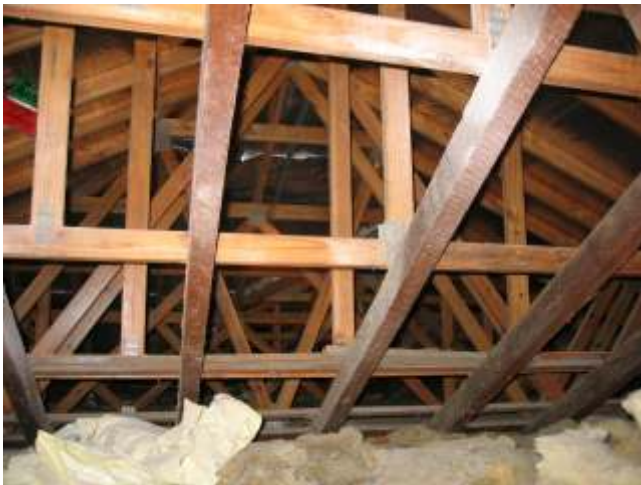
The photos below show a roof loft area that is of trussed construction which appears to comply with the code as to when this dwelling was first built. Access was hindered in this roof loft area by the valley series trusses and the A/C unit and its ducting.

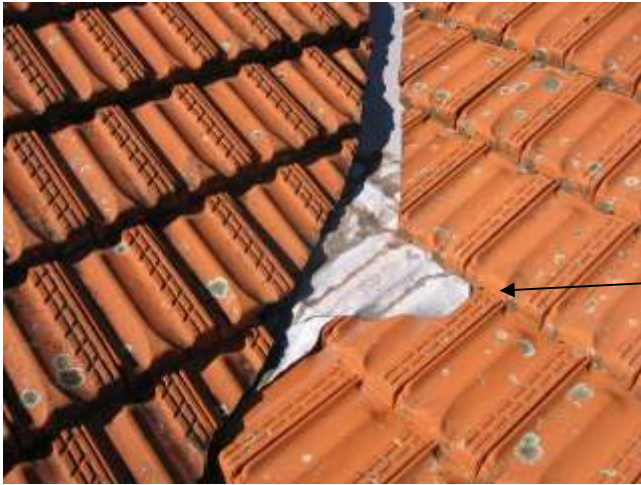
The lead flashings to the roof tile areas need to be painted to prevent further deterioration.

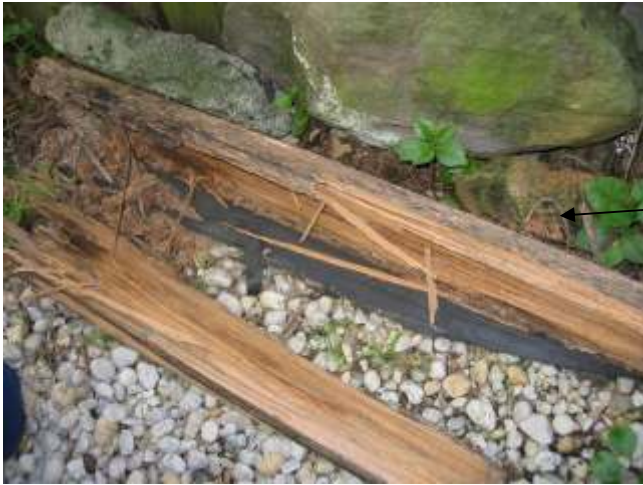
We make a general observation that there are Termite damaged timbers evident in the yard areas.

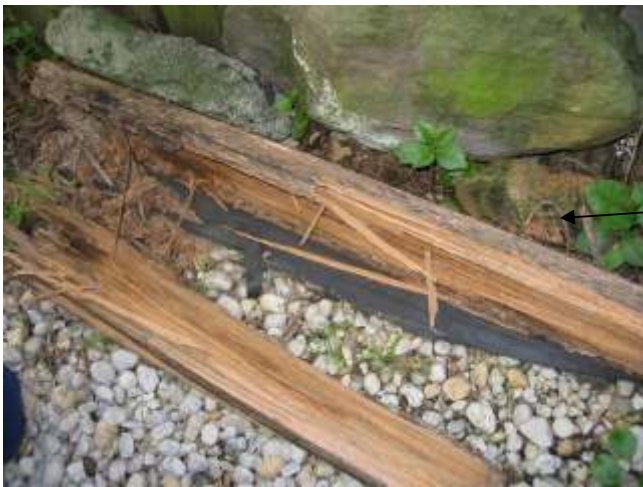
We make a general observation that there are Termite damaged timbers evident in the yard areas.

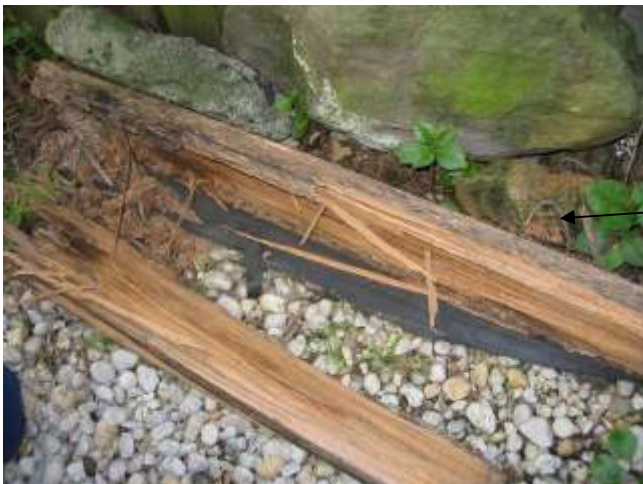
We make a general observation that there are Termite damaged timbers evident in the yard areas.

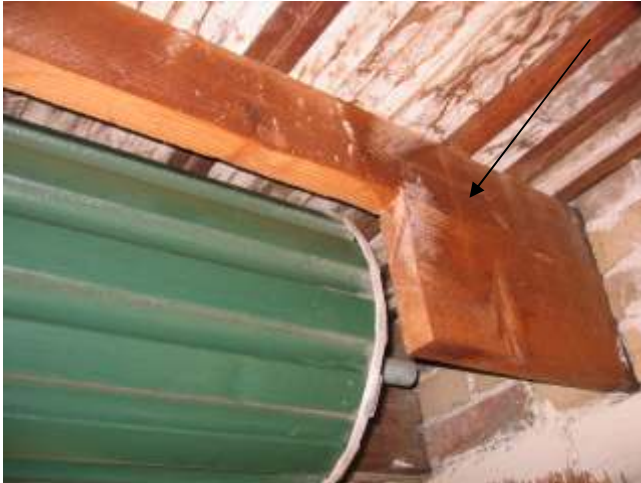
This garage ceiling joist has been poorly cut out to fit the roll-a-door, poor tradesman like works.

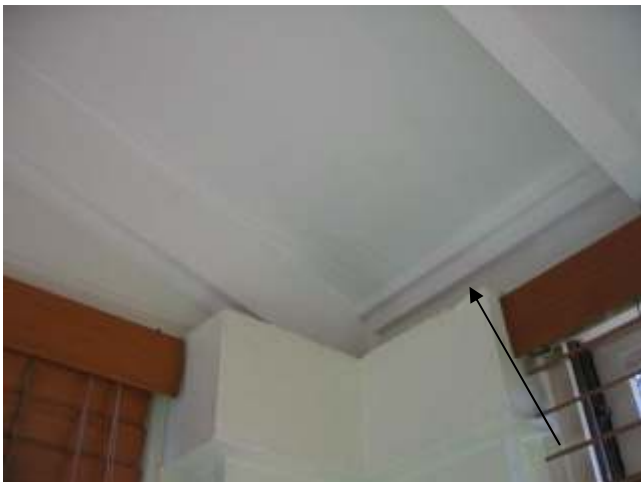
The front veranda room ceiling appears to be water stained from leaking above this area.

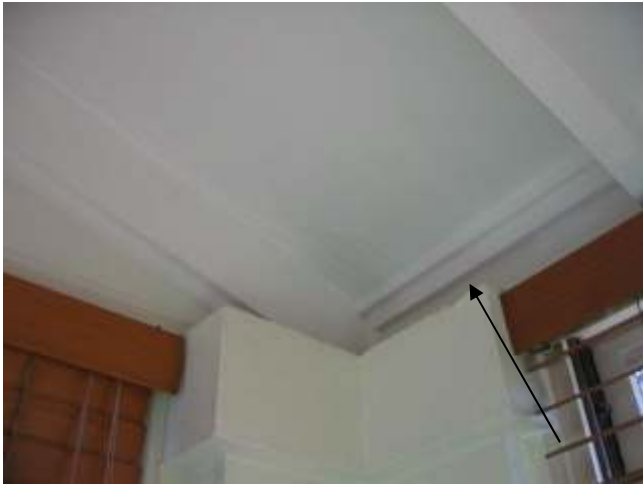
The front veranda room ceiling appears to be water stained from leaking above this area.

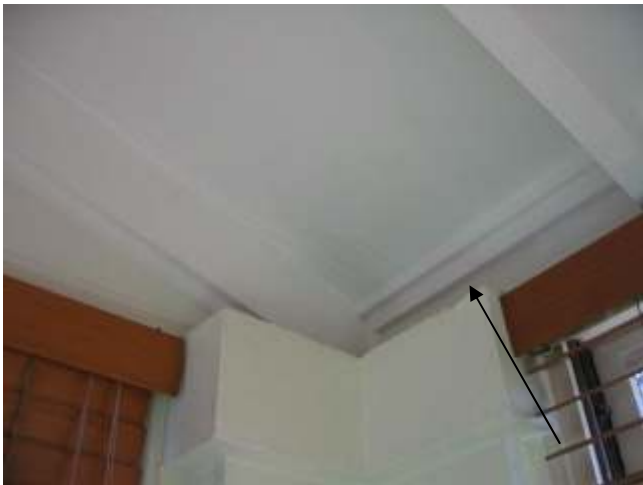
The front veranda room ceiling appears to be water stained from leaking above this area.

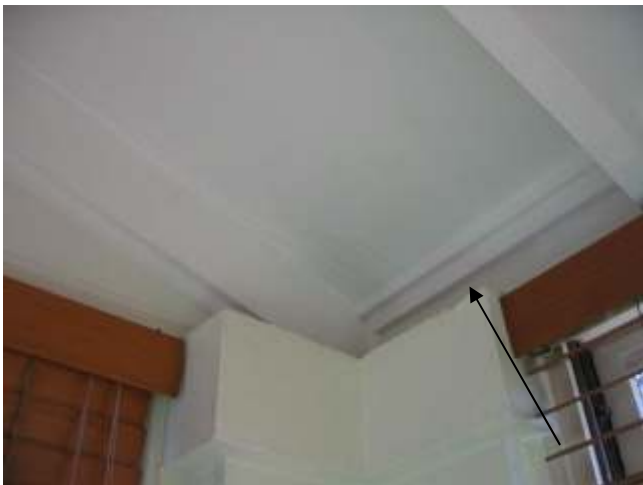
The front veranda room ceiling appears to be water stained from leaking above this area.
