Pre-Purchase Inspection - Building Report

Complies with Australian Standard AS 4349.1 - 2007

Dwelling at:

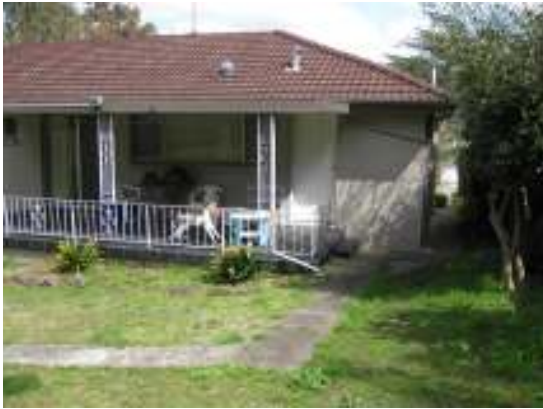
Out building/s: Unit was in poor/fair/average condition, unit needs to be demolished, gutters in poor and rusted condition, asbestos lined in areas, timber frame is wood decay affected in areas.

Granny Flat unit/As Inspected.
